1899 COCHRANE STREET

SAANICH, BC

CONSTRUCTION IMPACT ASSESSMENT

TREE MANAGEMENT PLAN

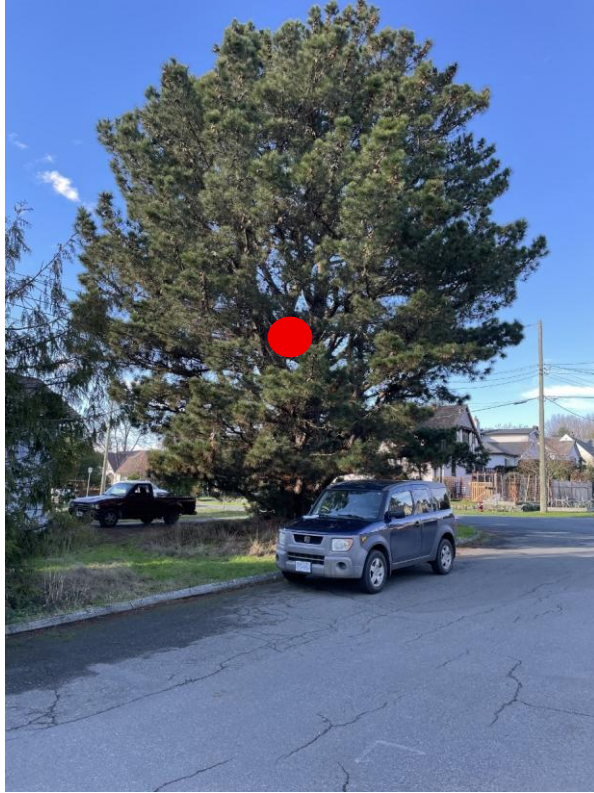
Tree ID: 2249 – Is a large Ponderosa pine tree located at the corner of the Cochrane Street and Dean Avenue. This tree is likely to be impacted by the building foundation, parking stall, fence and building clearance required for unit 1, along with the municipal frontage upgrades (sidewalk, curb and gutter) at the corner of Cochrane Street and Dean Avenue.

Image 1: Tree 2249 (red dot). Proposed as Retain*

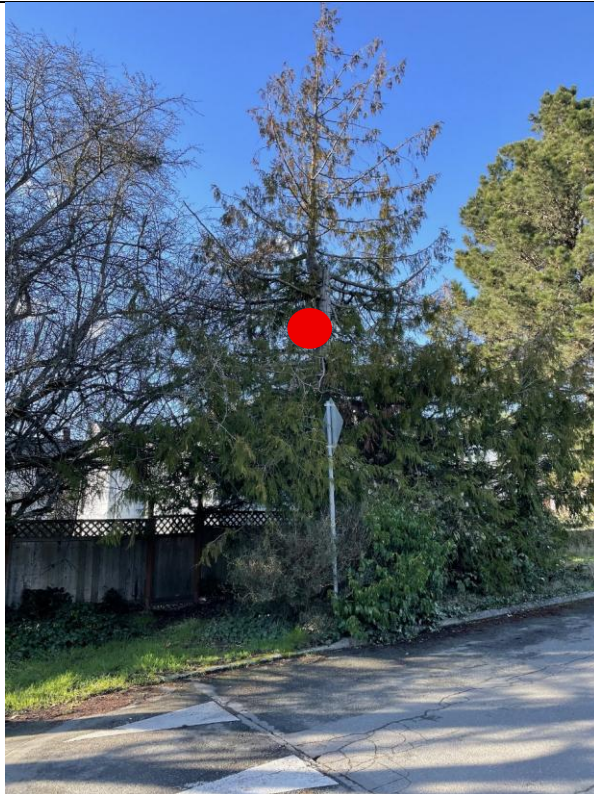
Tree ID's: 2250, 2251 – Are located on the municipal boulevard along Dean Avenue. These trees are located where they are likely to be impacted by the proposed construction. These trees are selected for removal based on a combination of impacts and their pre-existing condition.

Image 2: Tree 2250 (red dot). Selected for removal.

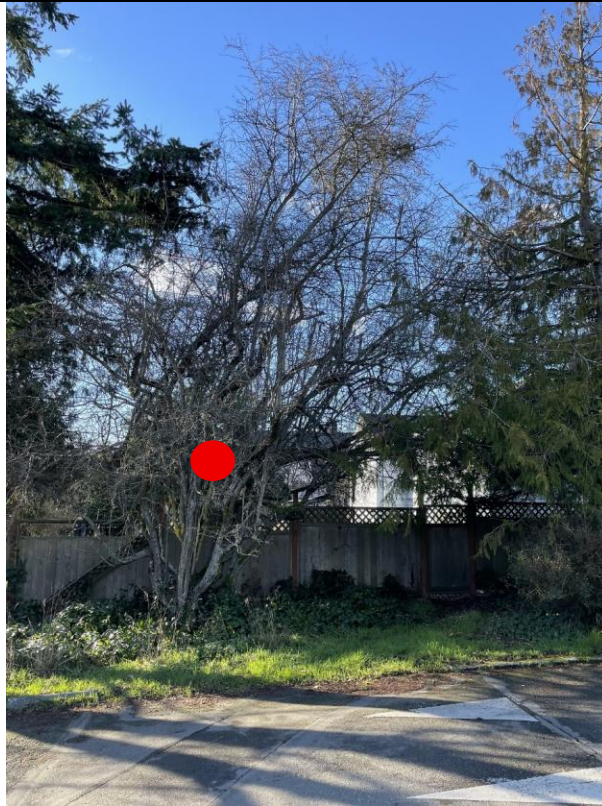
Image 3: Tree 2251 (red dot). Selected for removal.

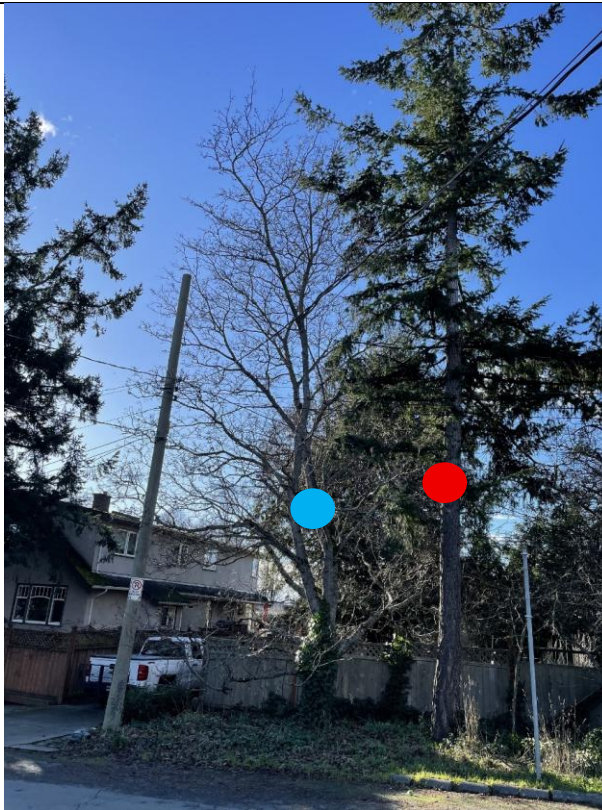
The proposed sanitary service line is ~2.4m south of tree 2253 with the storm service line being approximately 2m south of the sanitary line. We anticipate roots will be encountered during the excavation required for these service connections. During our on-site review in this area with Saanich's parks department on January 22nd, 2025, it was noted that the existing service lines were ~1-1.5m deep. It is to our understanding that these new services will have to be tied into the existing mains at this depth. Because of this depth required, we believe it may be possible to preserve critical rooting structures if encountered during excavation, as long as they are located above the required depth. These services are to be excavated using a hydro-vac and under arborist supervision. See [Appendix A, T1](#).

Image 4: Trees 2252 (red dot) & 2253 (blue dot). Both proposed as Retain*

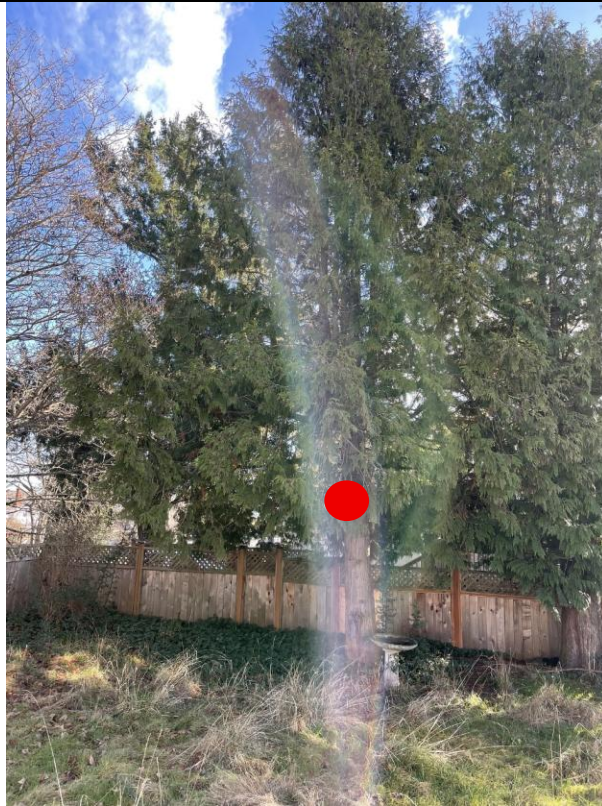
2254	Yes	On	Yes	Western Red cedar	Thuja plicata	43.00	5	6.45	Good	Fair	Poor	Topped historically	See section 8.2.1	Remove
2255	Yes	On	Yes	Western Red cedar	Thuja plicata	64.00	6	9.6	Good	Poor	Poor	Topped historically. Weakness and decay at union	See section 8.2.1	Remove

Image 5: Tree 2254 (red dot). Proposed for removal.

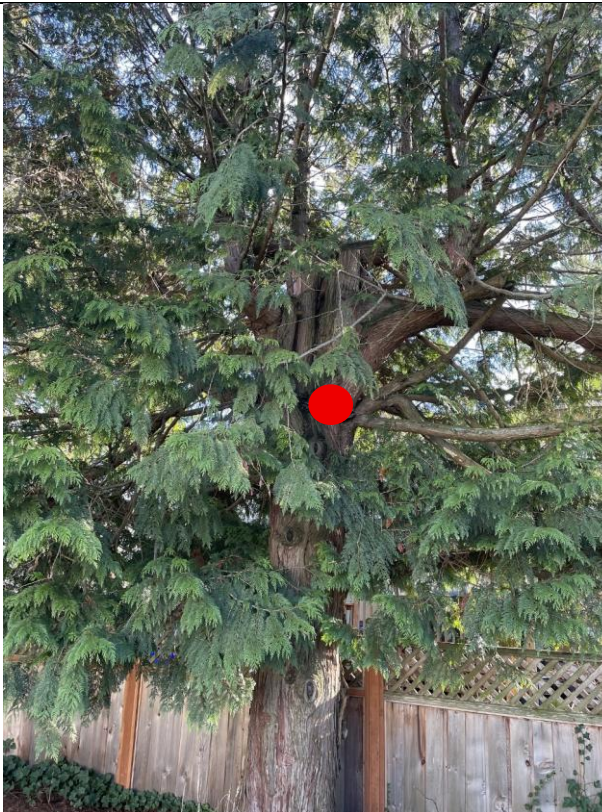
Image 6: Tree 2255 (red dot). Proposed for removal.

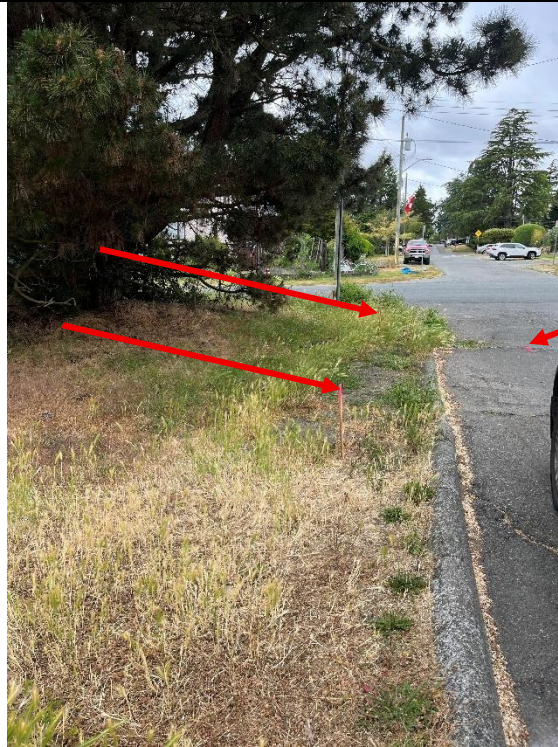
Image 7: To our understanding the proposed back of sidewalk (wooden stake) and curb (pink line), on the east side of tree 2249 (Dean Avenue) were surveyed. See red arrows.

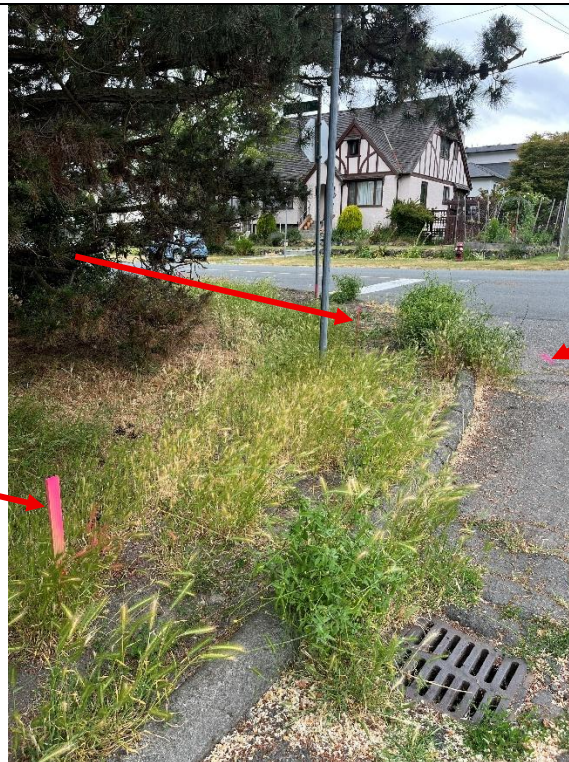
Image 8: To our understanding the Proposed back of sidewalk (wooden stake) and curb (pink line), on the east side of tree 2249 (Dean Avenue) were surveyed. See red arrows.

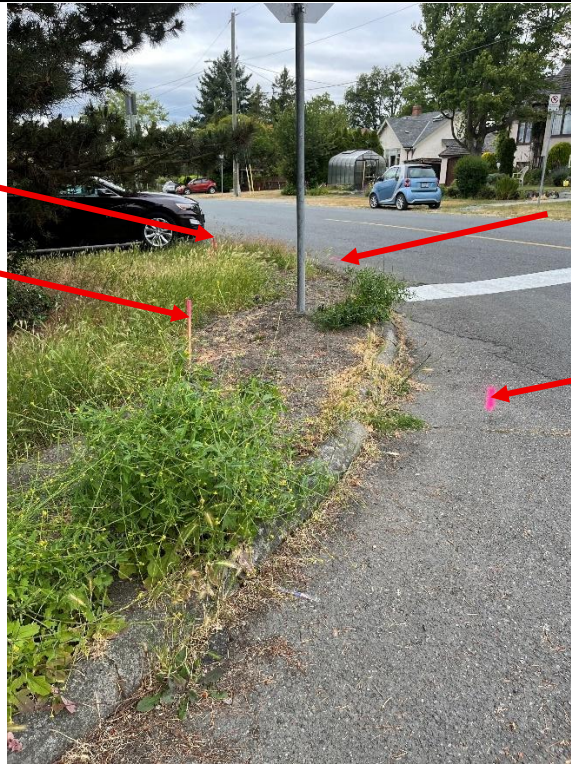
Image 9: To our understanding the Proposed back of sidewalk (wooden stake) and curb (pink line), on the northeast of tree 2249 (corner of Cochrane Road and Dean Avenue) were surveyed. See red arrows.

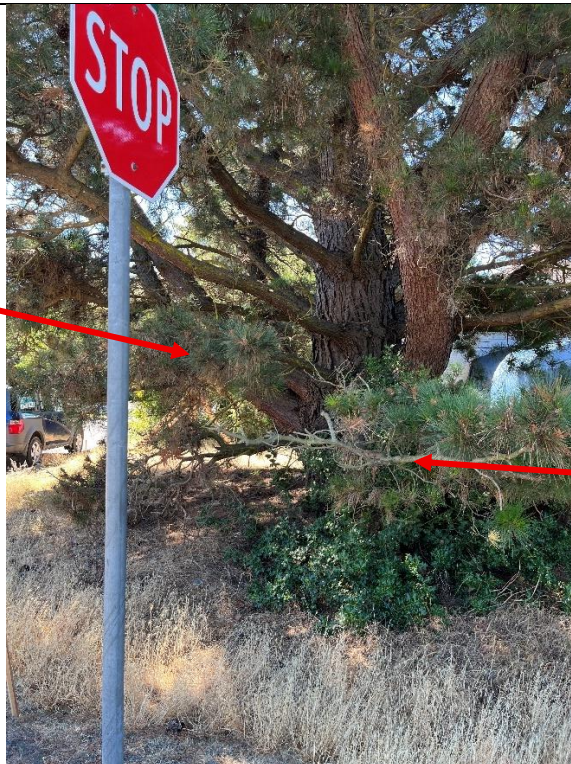
Image 10: North side of tree 2249. Branches likely requiring removal for sidewalk clearance (red arrows). The project arborist should be on-site to coordinate and clarify what branches need to be pruned.

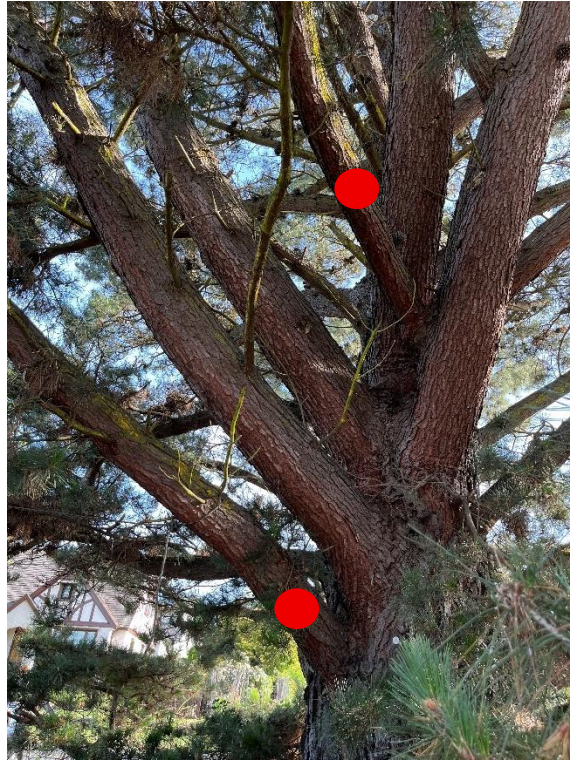
Pruning the 12cm branch back to where it attaches to the trunk will result in a pruning cut that is approximately 14cm in diameter. We do not anticipate this pruning would have a significant impact on this tree. It is recommended the project arborist be on-site to coordinate the branches that will require removal.

Image 11: 1x25cm & 1x~18cm branches in diameter likely to require removal for the building corner of unit 1 (red dots). The project arborist should be on-site to coordinate and clarify what branches need to be pruned.

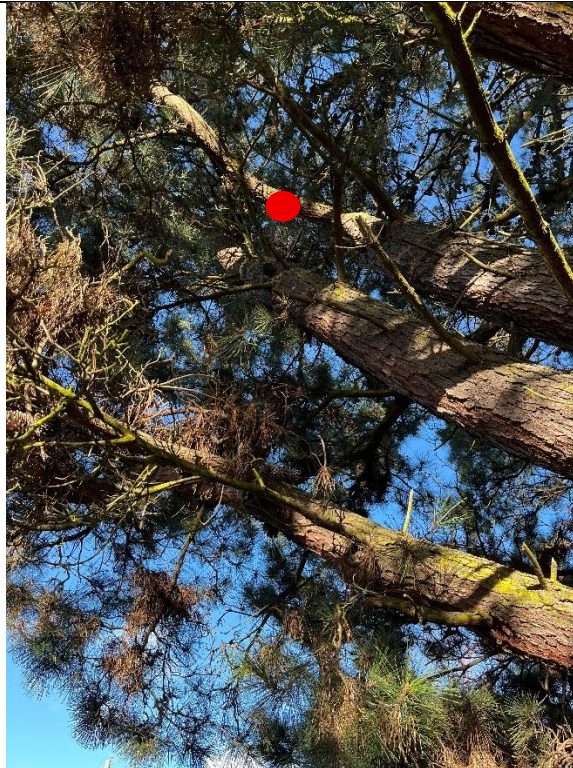
Image 12: 1x~18cm branch in diameter likely to require removal for the building corner of unit 1 (red dot). The project arborist should be on-site to coordinate and clarify what branches need to be pruned.

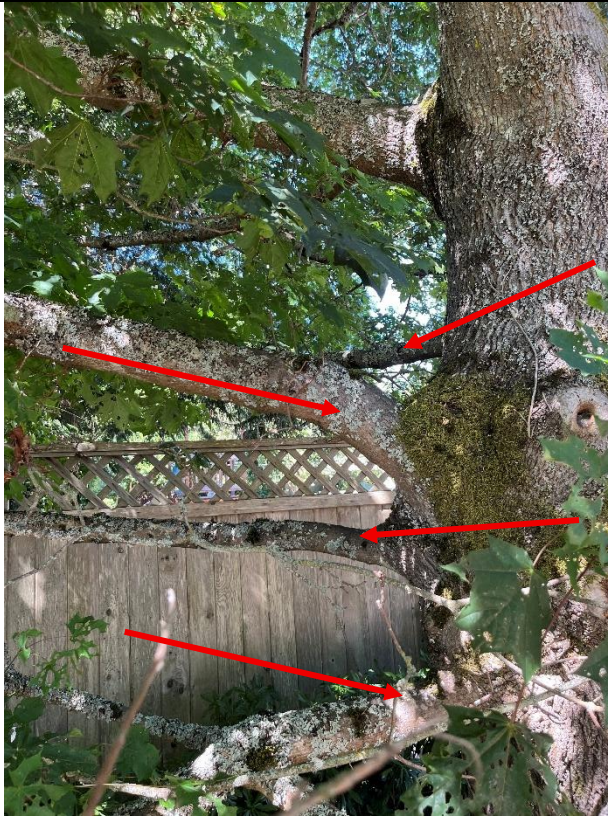
Image 13: 3x7cm & 1x~14cm branches in diameter from tree 2253 will likely require removal to accommodate machine access for the servicing installation and to provide clearance for the proposed sidewalk (red arrows).

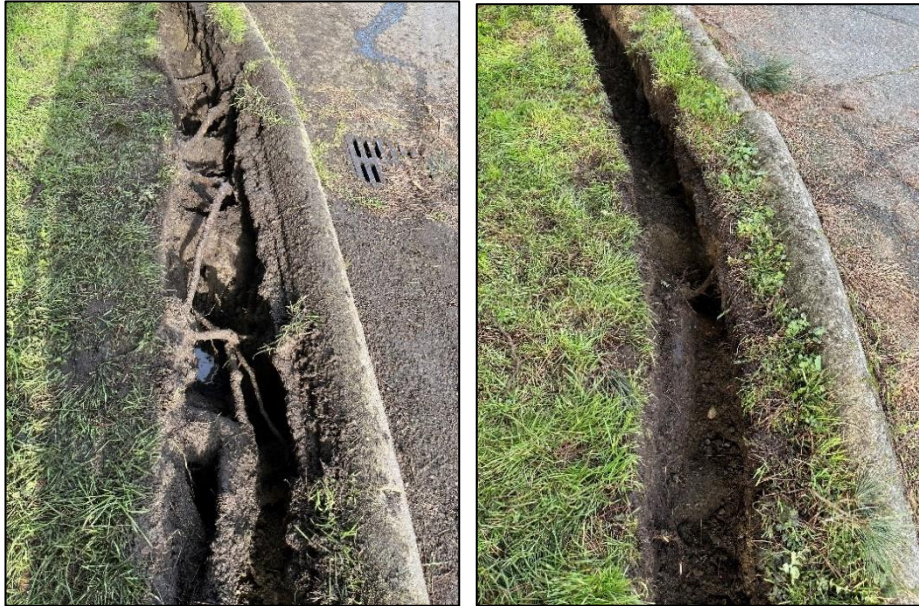
Photographs 1 & 2: Larger rooting structures (~10-20cm in diameter) were exposed approximately 5-6.5m east of tree 2249 near the existing catch basin on Dean Avenue (**left photo**). More larger rooting structures encountered ~5-6m northeast from the root collar of tree 2249 (**right photo**).

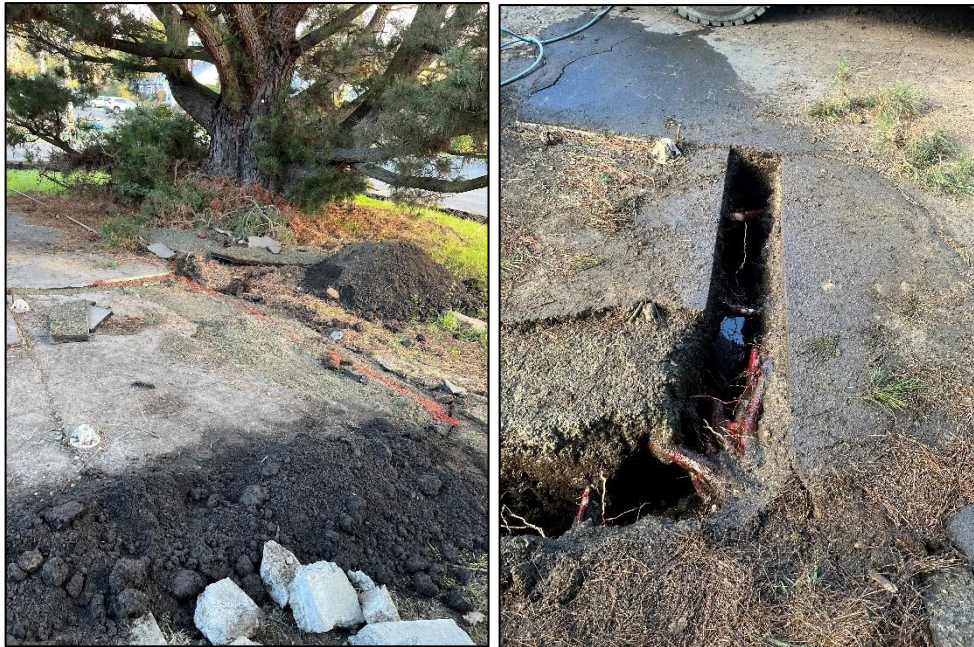
Photographs 3 & 4: Area on the southwest side of the tree was marked out for the exploratory excavation (**left photo**). Rooting structures encountered during the southwest hydro-vac excavation (**right photo**). These structures will have to be pruned during the over-excavation for the building footprint.

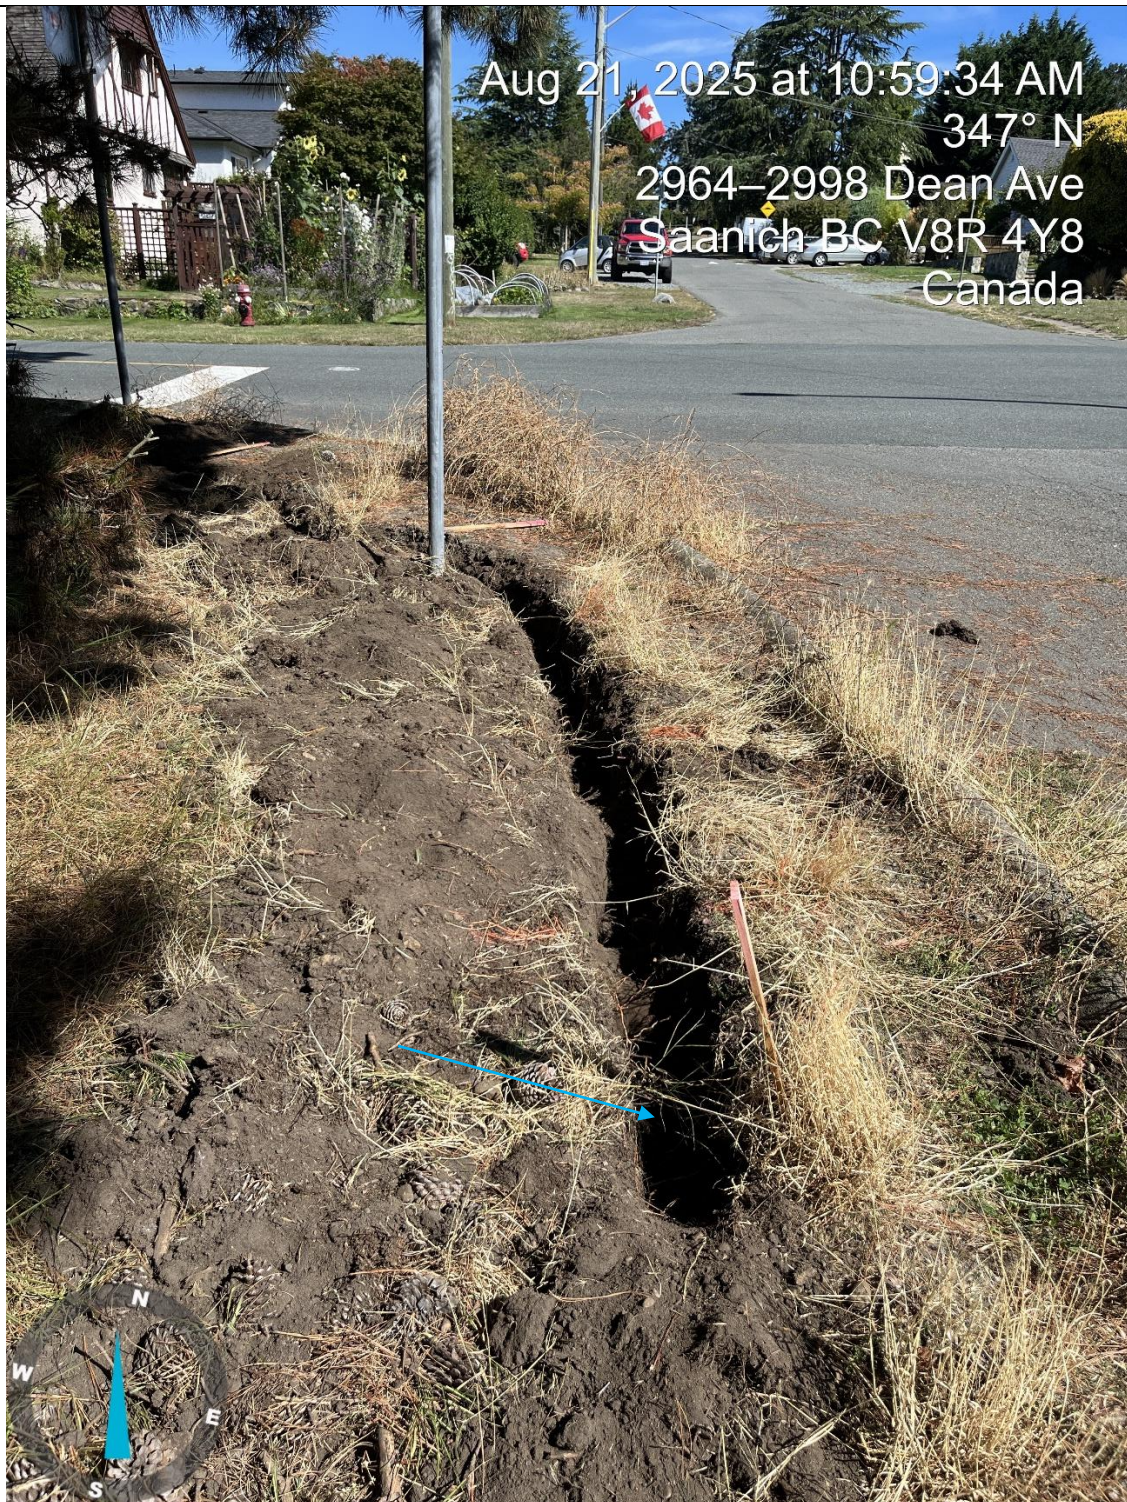
The roots encountered during all of the exploratory excavations on the east side of the tree were found to be ~20-25cm below the existing grade of the boulevard. The depth of these roots may be closer to the surface beneath the existing pavement within the existing road footprint. During our excavation we noted that the grade slopes away from the curb as it gets closer to the tree, therefore it should be possible to elevate the sidewalk above the roots and use conventional construction techniques within most of the sidewalk footprint. With the proposed top of curb being roughly 15 cm above the roadway grade, this puts it approximately 2.5-3.8cm above the existing boulevard grade. The sidewalk surface has to match the height of the concrete curb. With the roots being approximately 20-25cm below the existing boulevard grade, this gives an estimated 22.5-27.5cm of depth before the upper surface of any larger critical roots would be encountered. Typically, sidewalk installations require an excavation depth of 20cm for sub-base prep and concrete thickness. It is in our opinion that the use of alternative construction methods such as floating the sidewalk by using a geo-textile (e.g. Combigrid 30.30 – See **Appendix B**) over top of the larger rooting structures should be possible. In locations where excavation depth is required to reach material suitable for the sub-base prep and roots are encountered above this depth, these roots can be exposed by hand digging and then covered with a geotextile fabric prior to installing the base materials around the roots.

Photograph 1: Area of hand-dug exploratory excavation along the backside of the proposed sidewalk (wooden stake – red arrow) on the east side of tree 2249 (Dean Avenue frontage). Larger rooting structures previously encountered (blue arrow, difficult to see) were found to be 20-25cm below the existing boulevard grade.

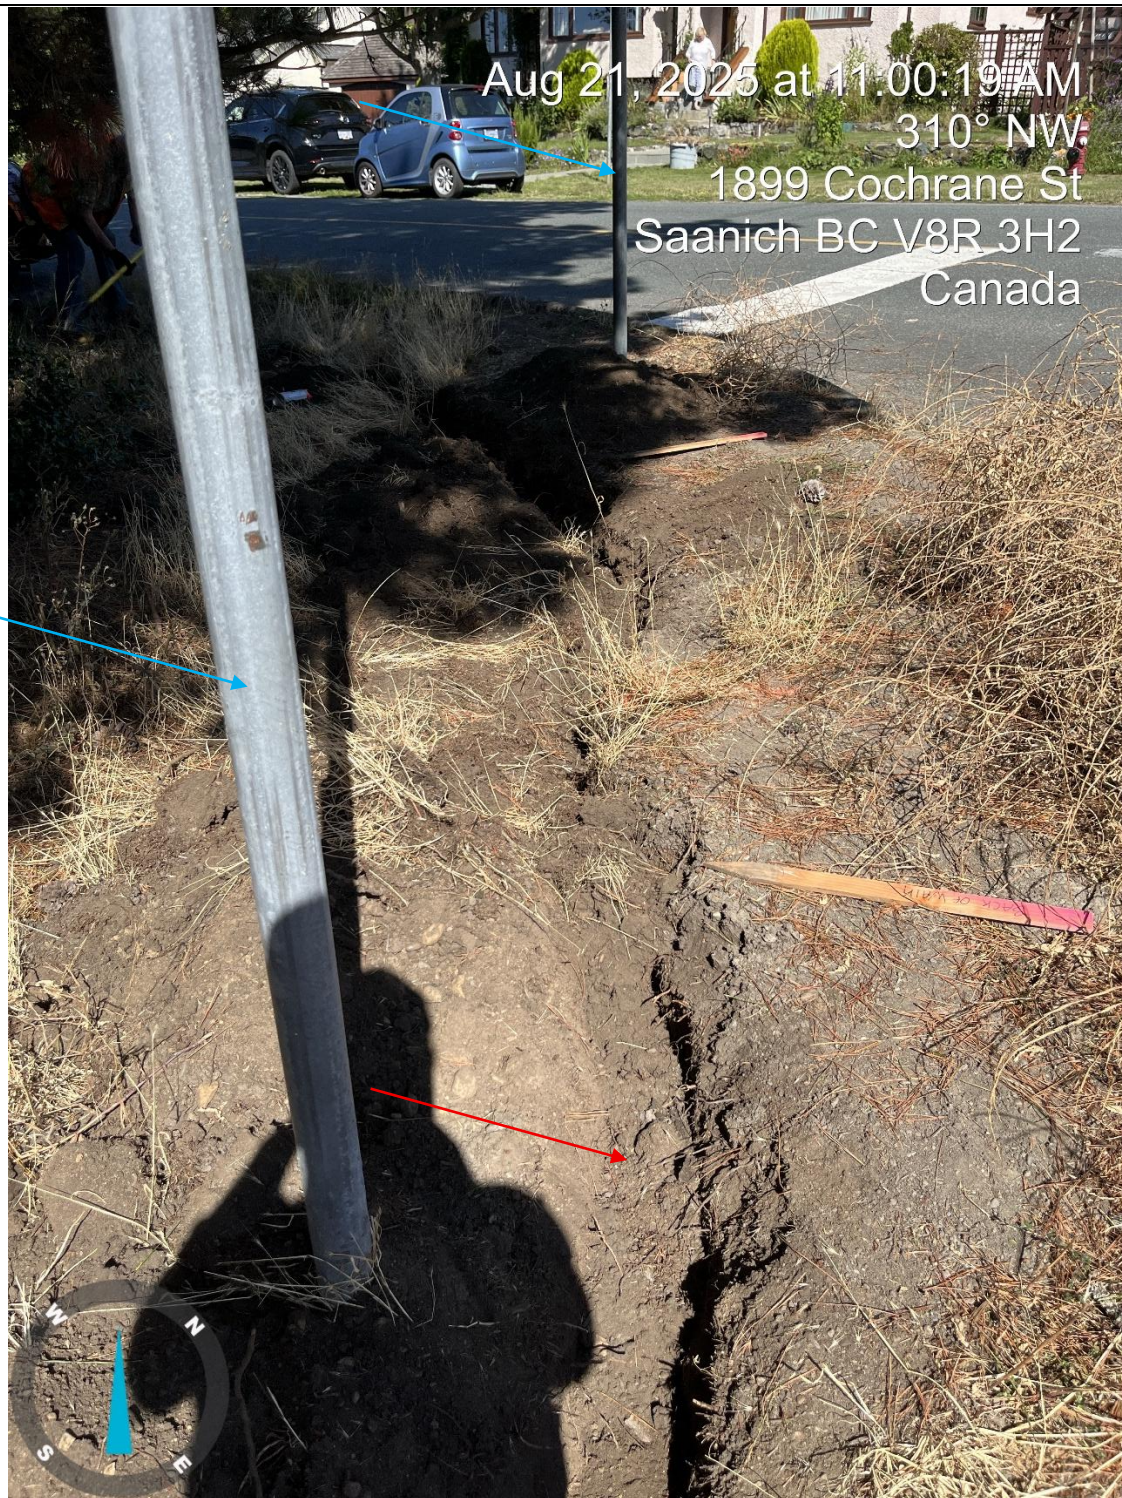
Photograph 2: Area of hand-dug exploratory excavation along the backside of the proposed sidewalk (wooden stake) on the northeastern side of tree 2249 (Corner of Dean Avenue and Cochrane Street). Larger ~12-14cm root (red arrow indicates approximately location, it is not visible in this photo) located near the base of existing street sign “no parking”. To our understanding the let down area of the sidewalk to the road grade is between the no parking street sign and the stop sign (blue arrows).

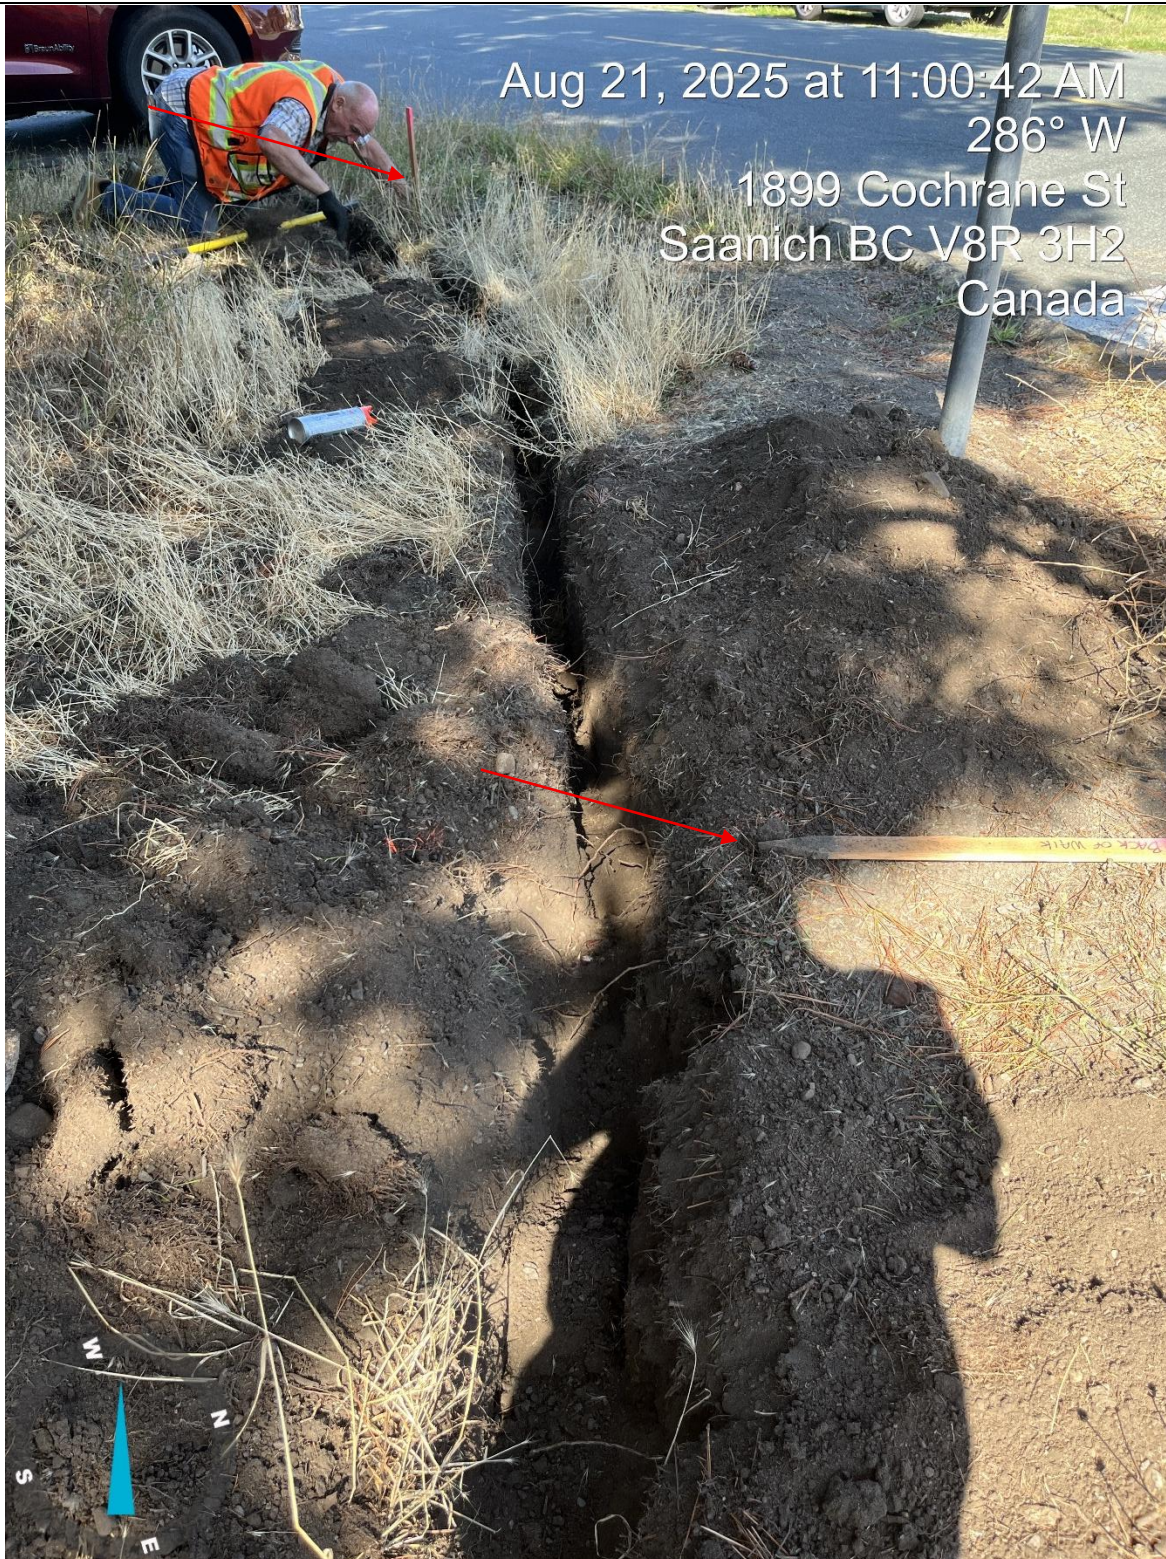
Photograph 3: Area of hand-dug exploratory excavation along the backside of the proposed sidewalk (wooden stake – red arrow) on the north/northeastern side of tree 2249.

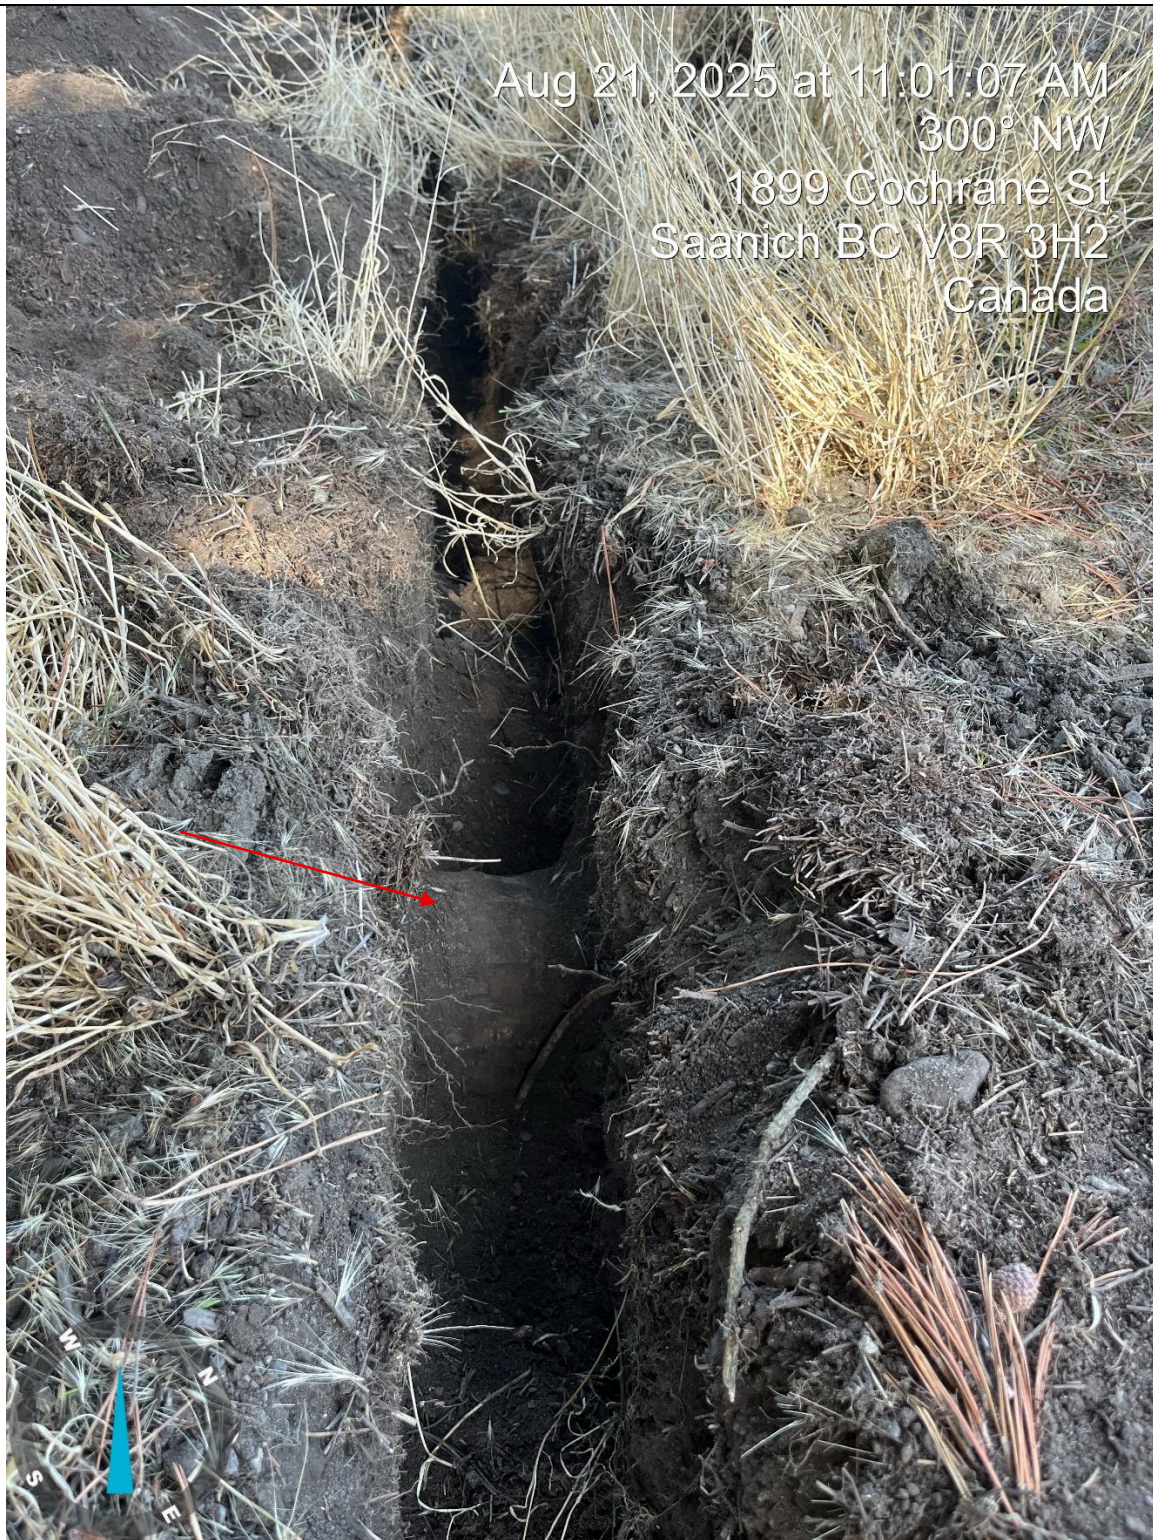
Photograph 4: Area of hand-dug exploratory excavation along the backside of the proposed sidewalk on the north side of tree 2249. Large ~12-14cm root (red arrow) was exposed roughly .25m west from the existing stop sign at the corner of Cochrane Street and Dean Avenue.

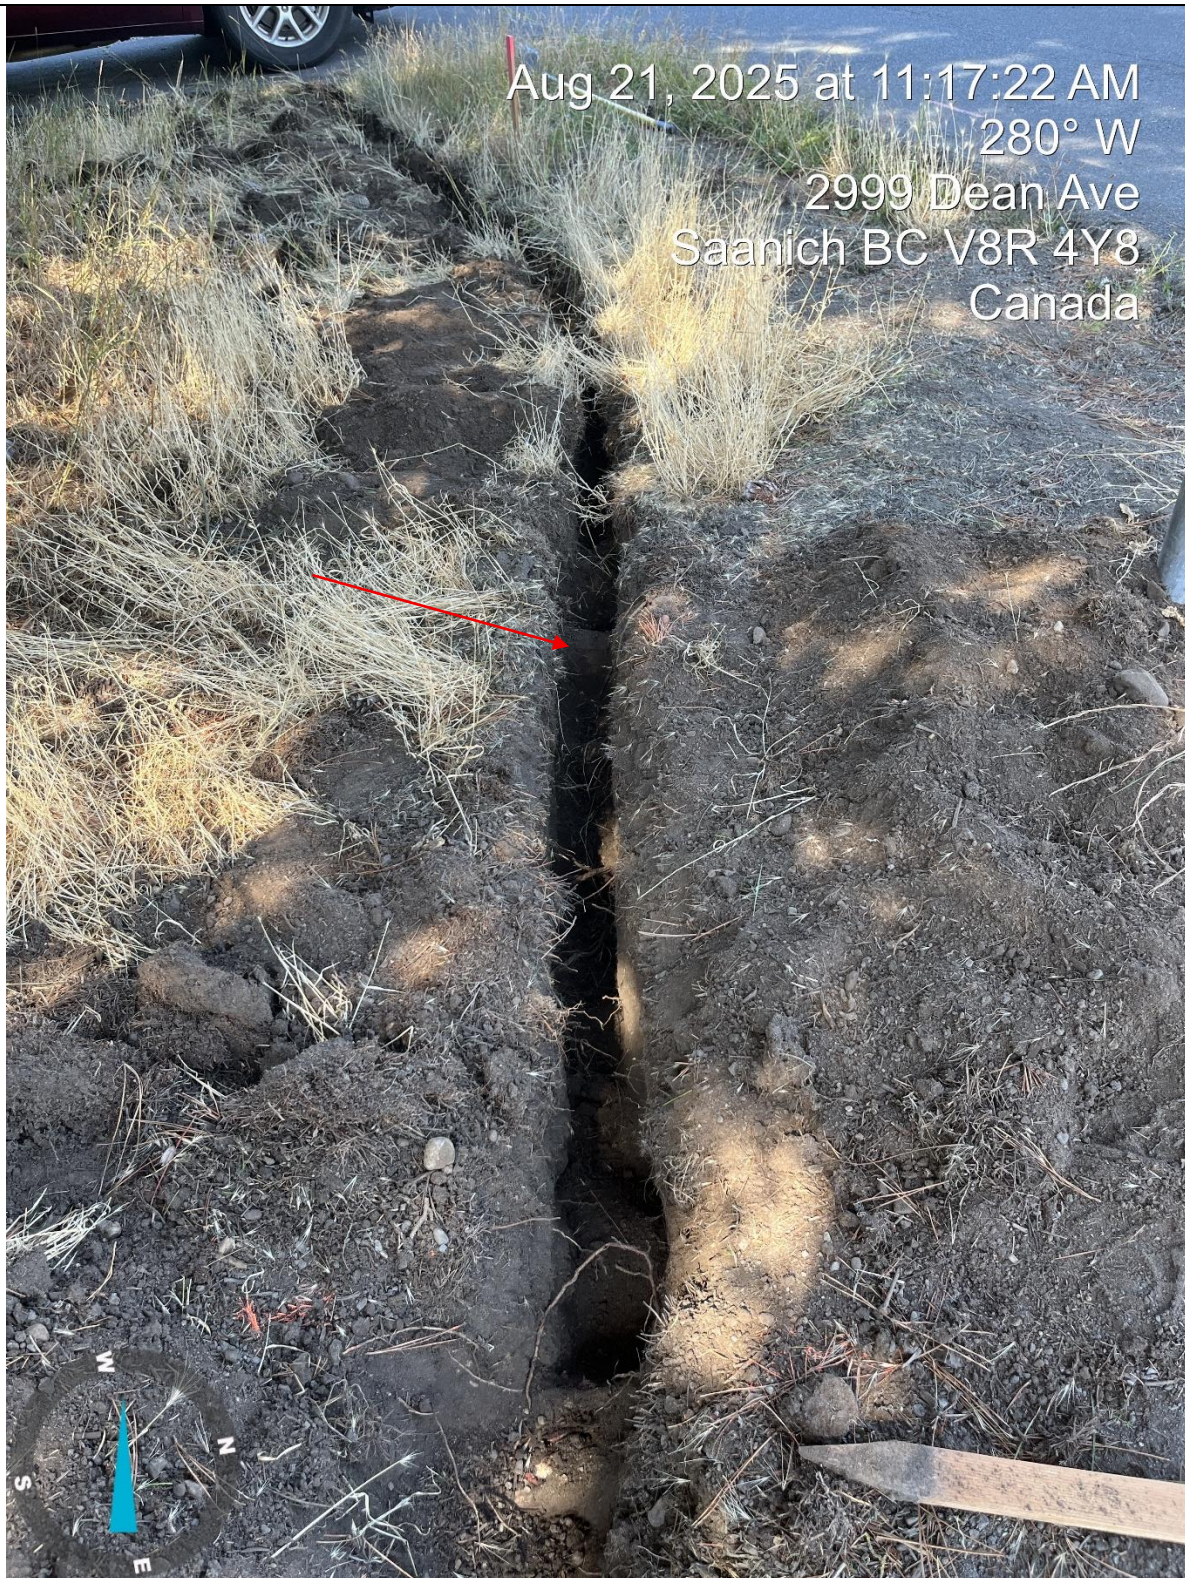
Photograph 5: Area of hand-dug exploratory excavation along the backside of the proposed sidewalk (wooden stake – red arrow) on the north side of tree 2249. The large ~12-14cm root exposed .25m from the existing stop sign can be seen (blue arrow).

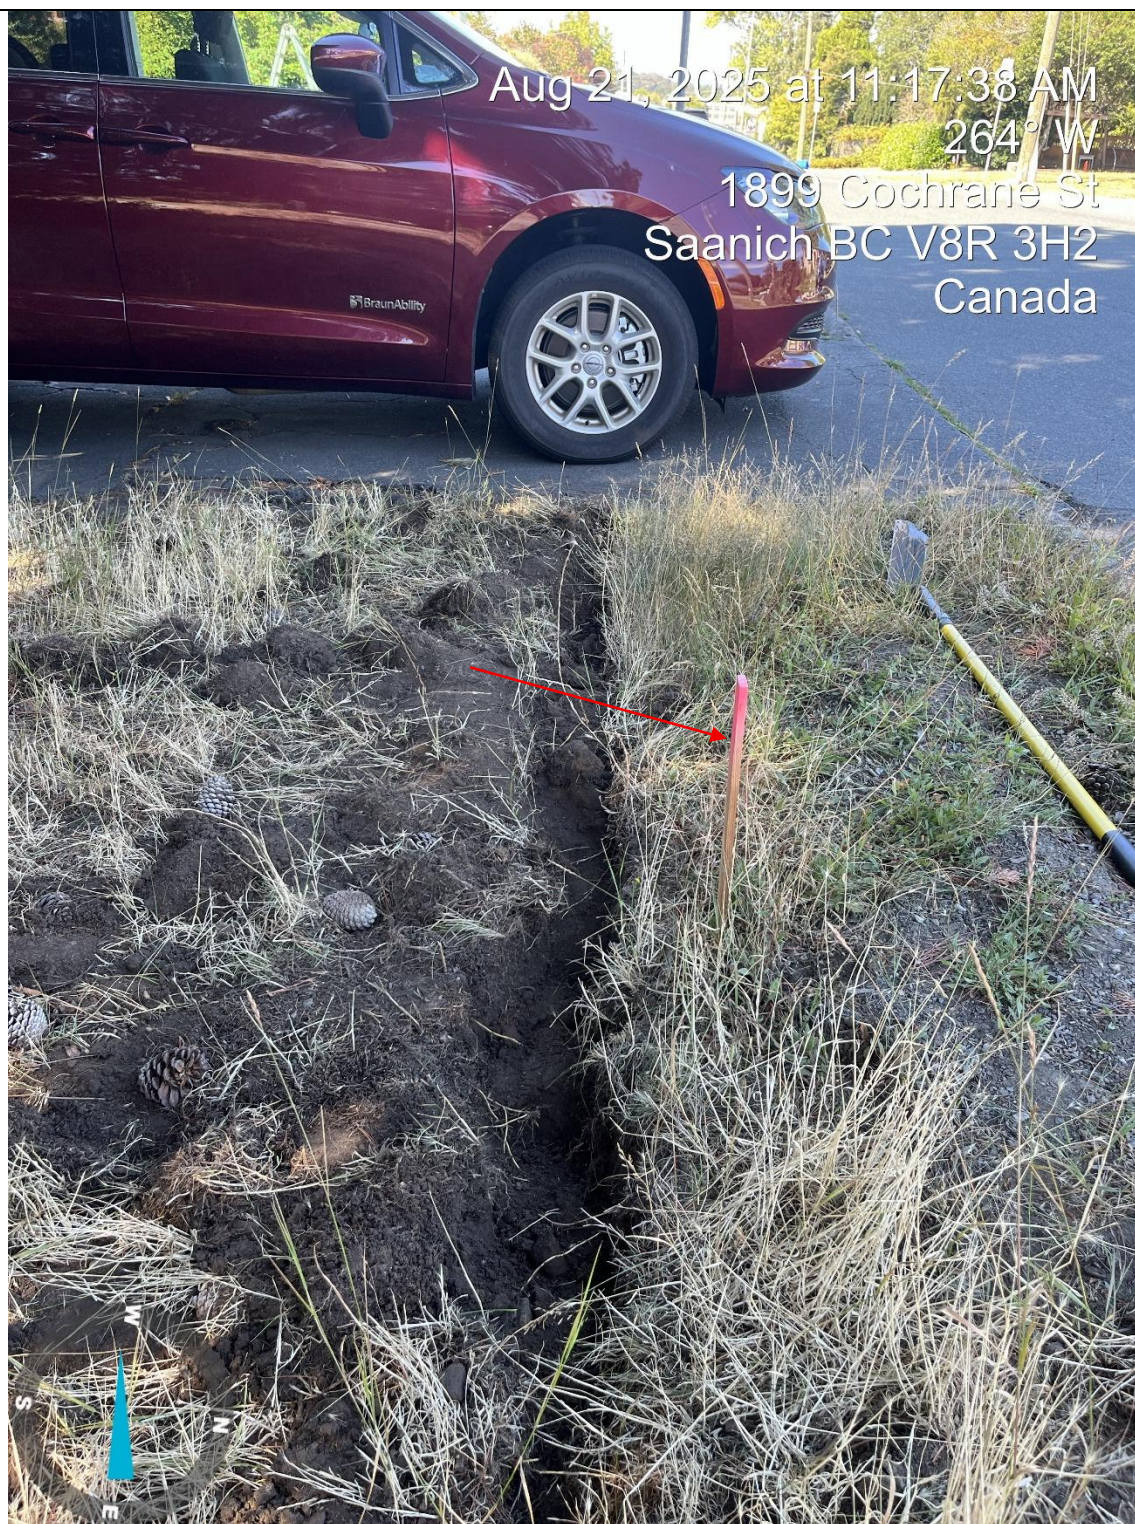
Photograph 6: Area of hand-dug exploratory excavation along the backside of the proposed sidewalk (wooden stake – red arrow) on the north side of tree 2249.

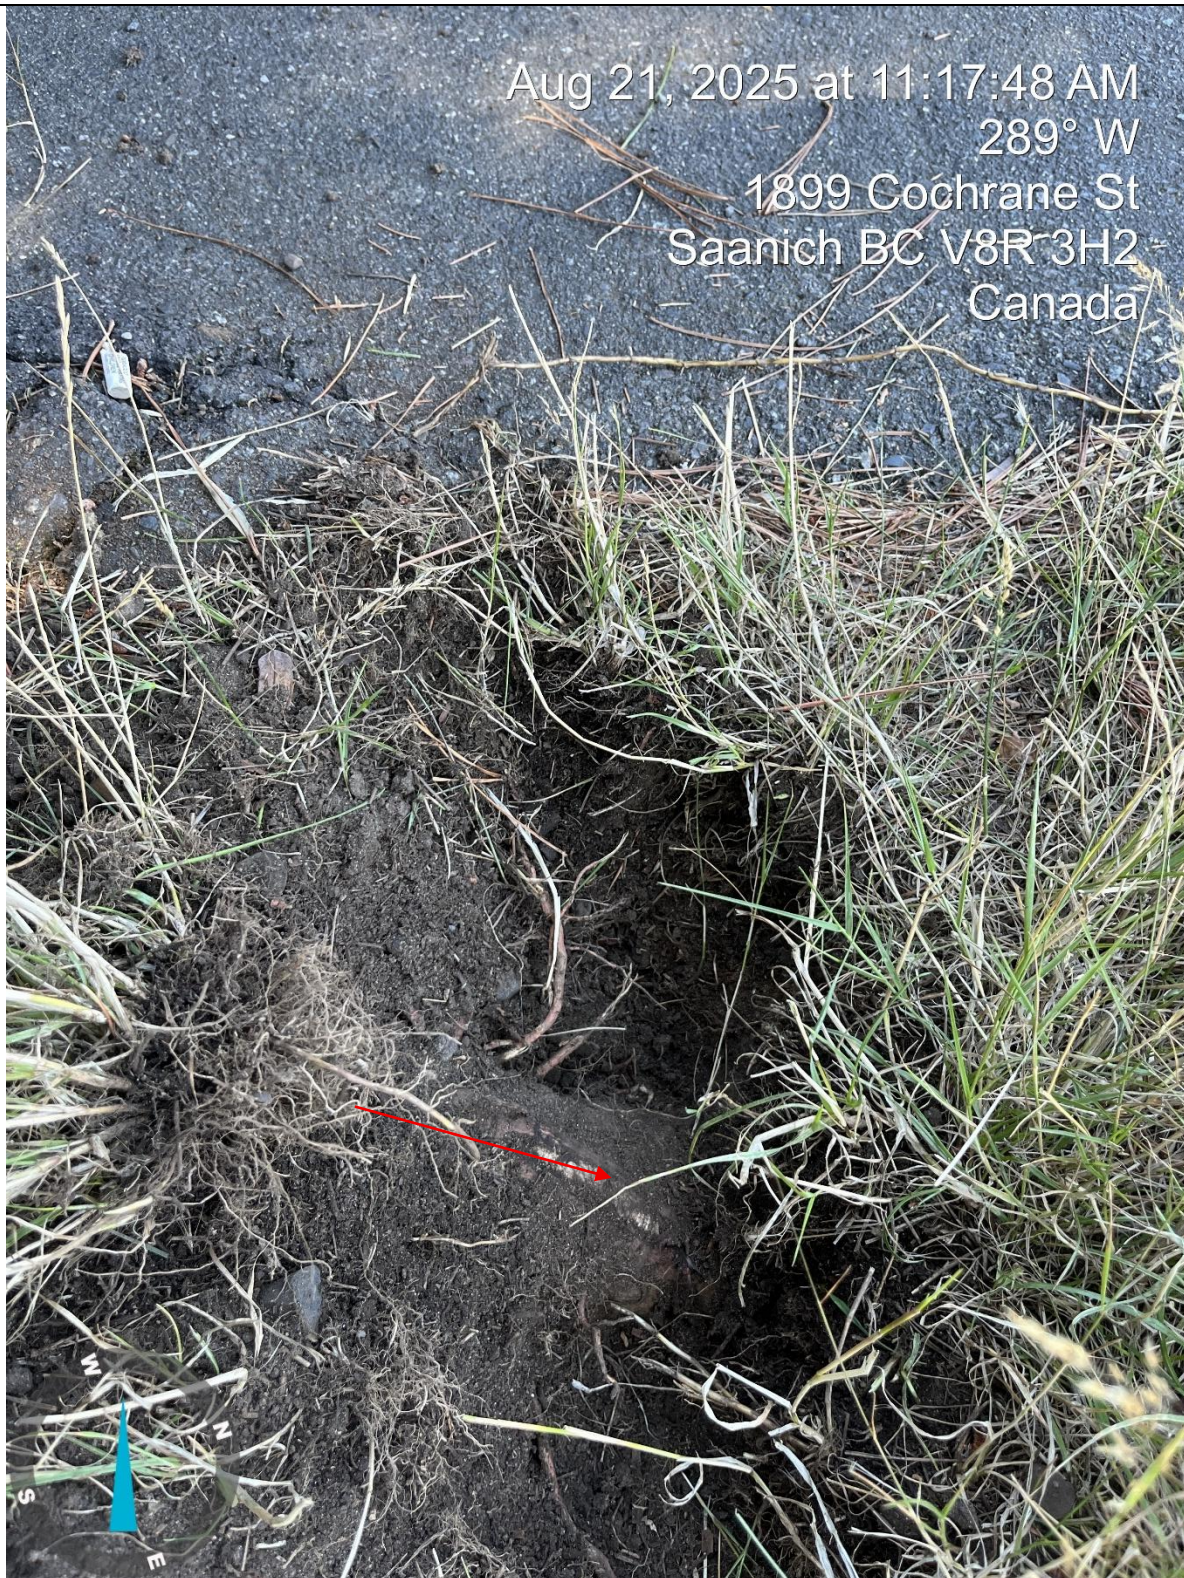
During our August 21st, 2025, exploratory excavation we found one root roughly 6cm in diameter at the edge of the existing driveway that may require pruning for the sidewalk due to its shallow depth (roughly 8cm below existing grade). We also encountered the previously exposed ~12-14cm root at the base of the existing “no parking” sign. This root was approximately 25-30cm below the existing boulevard grade. This root may be impacted by the let down area of the sidewalk. Slightly shifting the let down area of the sidewalk that connects to the roadway grade at the corner of Cochrane Street and Dean Avenue may be required to preserve this root. Based on our findings this should be feasible and involve little impacts to rooting structures.

Photograph 7: 1x6cm root (red arrow) exposed just east of the existing driveway during the had-dug exploratory excavation on the north side of tree 2249 along the Cochrane Street frontage.
