**961 Mckenzie Avenue, 3986 & 3990**

**Saanich Road, Saanich BC**

Demolition Impact Assessment,

Tree Management Plan

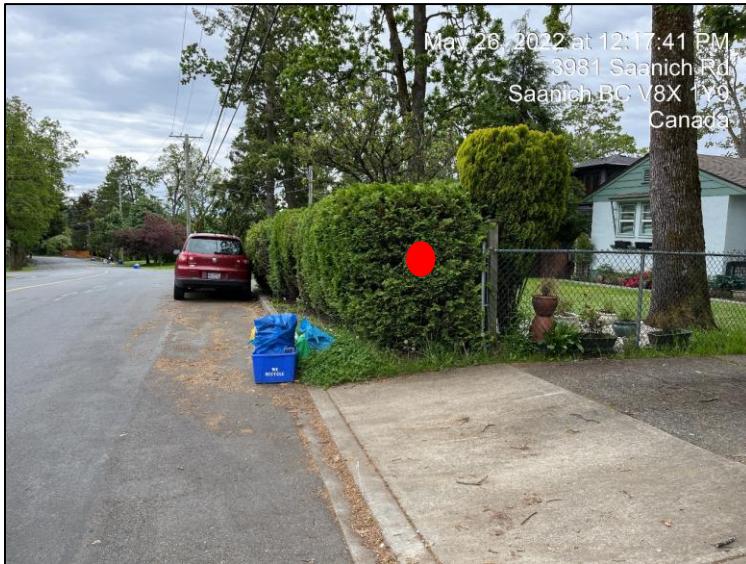
| Tag # | Surveyed<br>(Yes/No) | Location (On,<br>Off, Shared,<br>City) | Bylaw<br>protected<br>(Yes/No) | Name | | DBH (cm) | Crown<br>radius (m) | Critical<br>root zone<br>radius (m) | Condition | | Relative<br>tolerance | General field observations/remarks | Retention status |
|---|---|---|---|---|---|---|---|---|---|---|---|---|---|
| Hedge1 | Y | M | M | Western Red cedar | <i>Thuja plicata</i> | Multiple stems (13) between 10cm and 15cm | 1mx14m | 1.8 | Fair | Fair | Moderate | DBH measured at 1.0m and focus on primary stem prior to branching, surface rooting, some sections of die back, regularly pruned | Remove, Proposed sidewalk |

*Photograph 1 - Municipal hedge 1 (Red dot)*

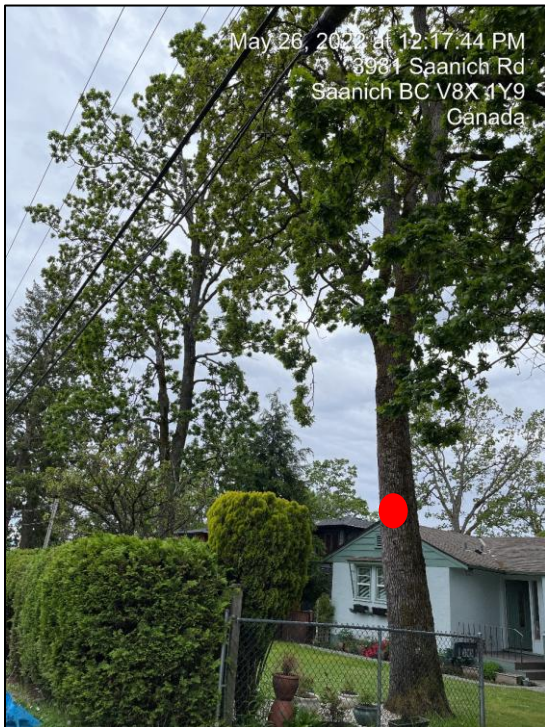
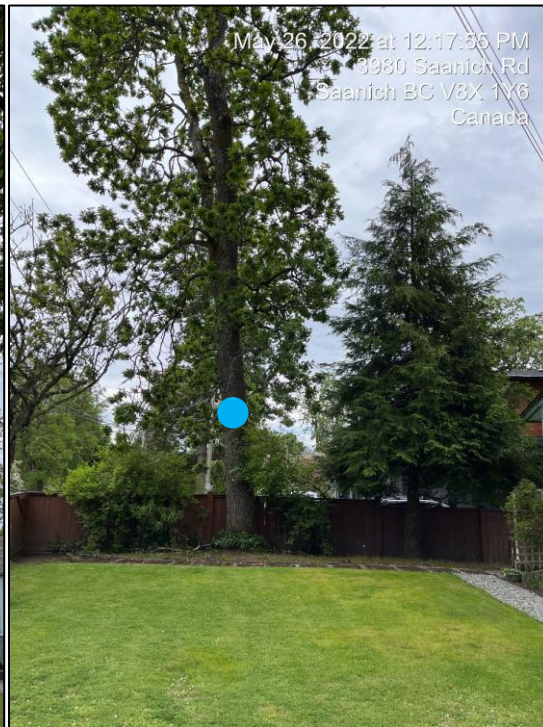
| Tag # | Surveyed<br>(Yes/No) | Location (On,<br>Off, Shared,<br>City) | Bylaw<br>protected<br>(Yes/No) | Name | | DBH (cm) | Crown<br>radius (m) | Critical<br>root zone<br>radius (m) | Condition | | Relative<br>tolerance | General field observations/remarks | Retention status |
|---|---|---|---|---|---|---|---|---|---|---|---|---|---|
| 47 | Y | On | Y | Garry oak | <i>Quercus garryana</i> | 69 | 9 | 6.9 | Fair | Fair | Good | Some die back within canopy, epicormic growth, dead wood, past failures, existing driveway within 1m north of root flare, nesting activity in upper dead wood | Remove, Building envelope |

*Photograph 3 & 4 - Garry oak 47 (Red dot) & Garry oak 50 (Blue dot). Both proposed for removal.*

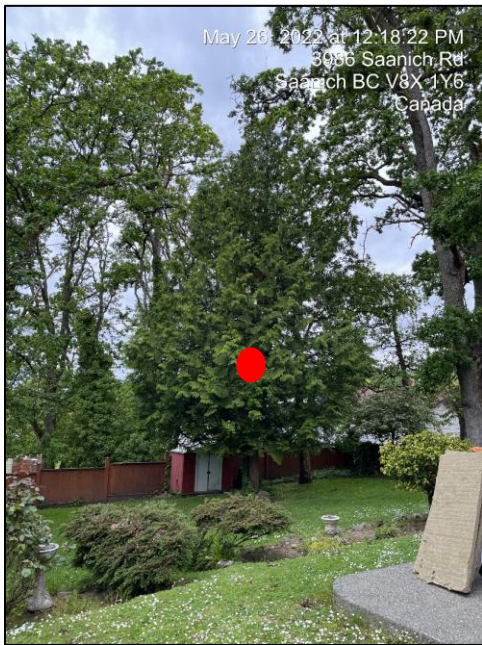
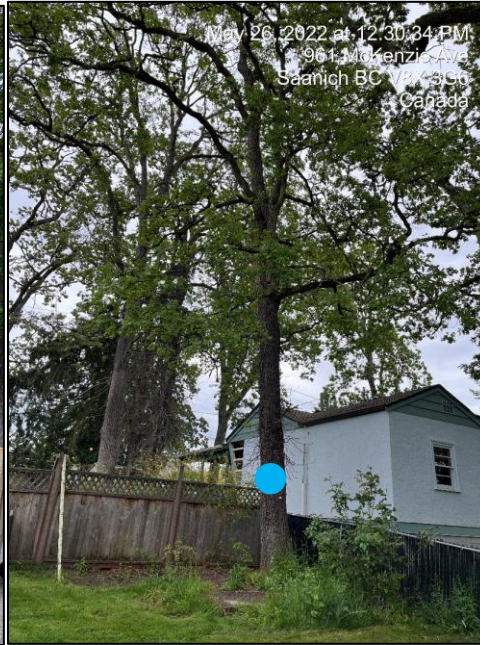
| Tag # | Surveyed<br>(Yes/No) | Location (On,<br>Off, Shared,<br>City) | Bylaw<br>protected<br>(Yes/No) | Name | | DBH (cm) | Crown<br>radius (m) | Critical<br>root zone<br>radius (m) | Condition | | Relative<br>tolerance | General field observations/remarks | Retention status |
|---|---|---|---|---|---|---|---|---|---|---|---|---|---|
| 55 | Y | On | Y | Western Red cedar | <i>Thuja plicata</i> | 68,31 | 5 | 9.096 | Fair | Fair to poor | Moderate | Multiple stems at 2m on the larger stem, active inclusions between multiple stems at 2m, surface roots with mechanical damage, small pile of fill positioned adjacent to the root flare on west side, cracking, and wounds along one of the stems on the nw side of the tree, some of the stems have past top failure. Bark stripped from 31 cm stem and bark damage on other stems stem | Remove, Building envelope |

| Tag # | Surveyed (Yes/No) | Location (On, Off, Shared, City) | Bylaw protected (Yes/No) | Name | | DBH (cm) | Crown radius (m) | Critical root zone radius (m) | Condition | | Relative tolerance | General field observations/remarks | Retention status |
|---|---|---|---|---|---|---|---|---|---|---|---|---|---|
| 59 | Y | On | Y | Garry oak | <i>Quercus garryana</i> | 58 | 8 | 5.8 | Fair | Fair to poor | Good | Possible included union at 6m, dieback, dead wood, historical failures, some epicormic growth, historical ivy, hanging dead wood, | Remove, Building envelope |

Photograph 5 & 6 – Red cedar 55 (Red dot) & Garry oak 59 (Blue dot). Both proposed for removal.

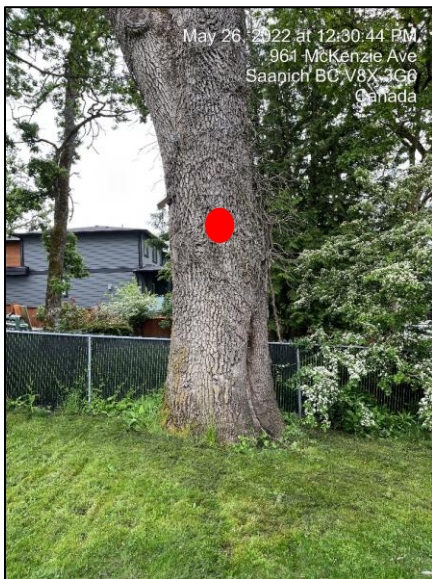
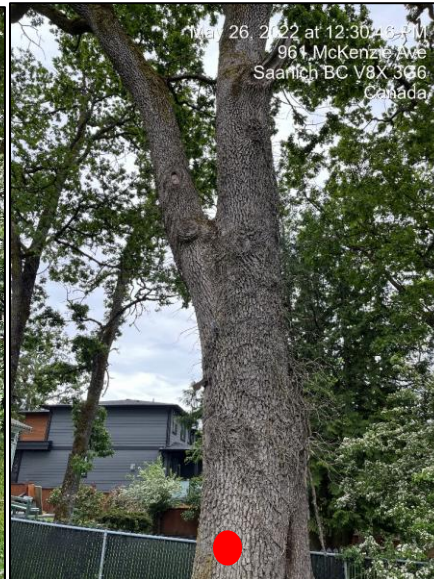
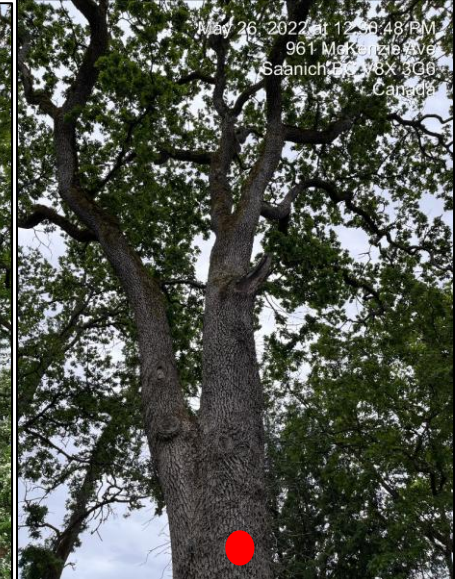
| Tag # | Surveyed (Yes/No) | Location (On, Off, Shared, City) | Bylaw protected (Yes/No) | Name | | DBH (cm) | Crown radius (m) | Critical root zone radius (m) | Condition | | Relative tolerance | General field observations/remarks | Retention status |
|---|---|---|---|---|---|---|---|---|---|---|---|---|---|
| 60 | Y | On | Y | Garry oak | <i>Quercus garryana</i> | 123 | 15 | 12.3 | Fair to good | Fair | Good | Large wound at base with reaction wood, large wound is about 1.5m in length and 0.3m width and 15cm depth, historical ivy, historical pruning of large scaffold limbs, pruning wounds with callous, past failure of large scaffold limbs, some die back in crown, possible included back between primary union at 6m, dominant tree, | Remove, Building envelope |

Photograph 7, 8 & 9 – Garry oak 60 (Red dot). Proposed for removal.

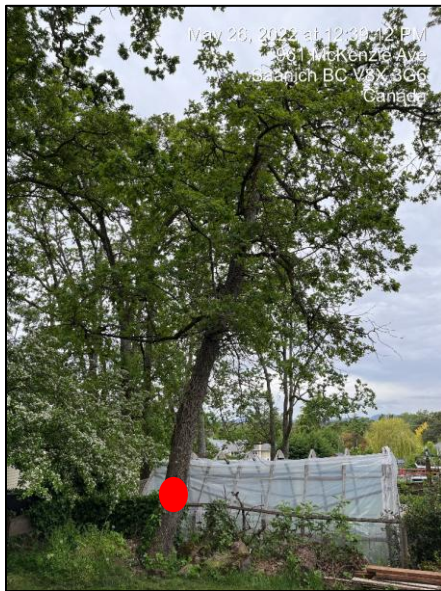
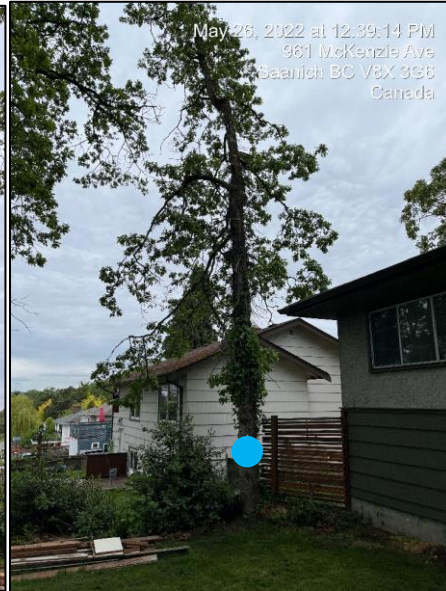
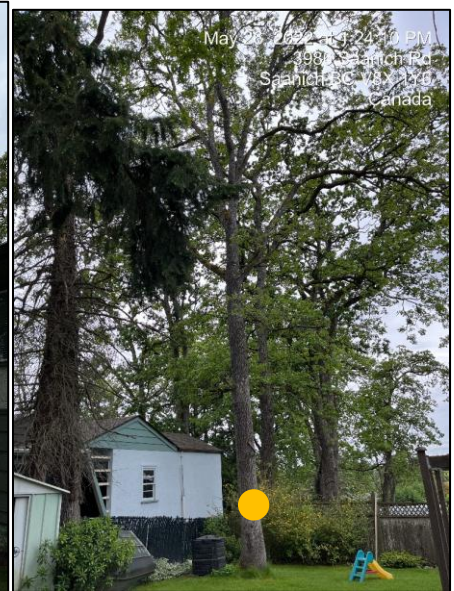
| Tag # | Surveyed (Yes/No) | Location (On, Off, Shared, City) | Bylaw protected (Yes/No) | Name | | DBH (cm) | Crown radius (m) | Critical root zone radius (m) | Condition | | Relative tolerance | General field observations/remarks | Retention status |
|---|---|---|---|---|---|---|---|---|---|---|---|---|---|
| 62 | Y | On | Y | Garry oak | <i>Quercus garryana</i> | 37 | 4 | 3.7 | Fair to poor | Fair to poor | Good | Turkey tail fruiting bodies along western side of lower trunk, mechanical damage of 2cm depth along lower western trunk, ivy, epicormic growth, thin canopy, narrow canopy, dead wood, moderate dieback, past failures, extended limbs, possible historical limb, and top failures, lean to the west | Remove, Building envelope |

Photograph 10, 11 & 12 – Garry oak 61 (Red dot), Garry oak 62 (Blue dot) & Garry oak 63 (Orange dot). All proposed for removal.

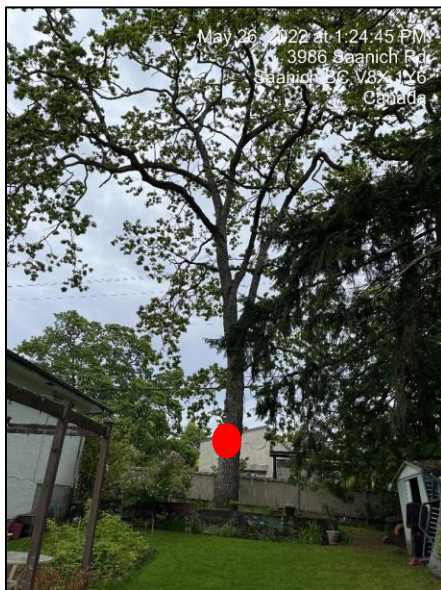
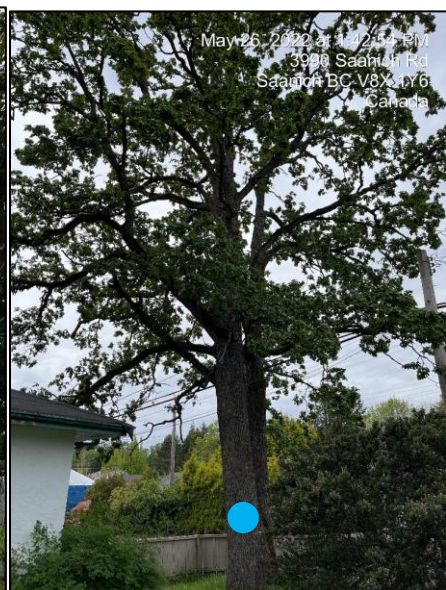
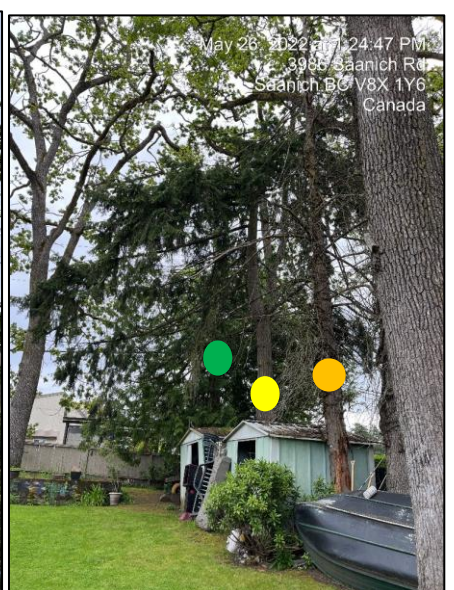
| Tag # | Surveyed (Yes/No) | Location (On, Off, Shared, City) | Bylaw protected (Yes/No) | Name | | DBH (cm) | Crown radius (m) | Critical root zone radius (m) | Condition | | Relative tolerance | General field observations/remarks | Retention status |
|---|---|---|---|---|---|---|---|---|---|---|---|---|---|
| 252 | N | On | Y | Western Red cedar | <i>Thuja plicata</i> | 33 | 0 | N/A | Dead | Dead | Moderate | Standing deadwood damage to lower trunk. Hazard tree. | Remove, Building envelope |
| 65 | Y | On | Y | Douglas-fir | <i>Pseudotsuga menziesii</i> | 45 | 6 | 5.4 | Fair | Fair to poor | Moderate | Multiple trunk deflections, deflected leader or failed leader, some twig dieback, suppressed by adjacent Garry oak, deadwood, | Remove, Building envelope |
| 67 | Y | On | Y | Garry oak | <i>Quercus garryana</i> | 78 | 10 | 7.8 | Fair to poor | Fair to poor | Good | Buttress roots to the east with some damage, dieback throughout canopy, callused pruning wounds, medium to large deadwood, some large dead wood over back yard with fungal fruiting bodies, possible included union at 6m, retaining wall to the west of root flare, health stress | Remove, Building envelope |
| 70 | Y | On | Y | Garry oak | <i>Quercus garryana</i> | 119 | 10 | 11.9 | Fair to good | Fair | Good | Possible included union at 1m, past failures some with callus, some epicormic growth, historical utility pruning, medium deadwood, some die back, relatively full crown | Remove, sidewalk/water lateral |

Photograph 13, 14 & 15 – Garry oak 67 (Red dot), Garry oak 70 (Blue dot), Red Cedar 252 (Orange dot), Douglas fir 65 (Yellow dot), & Red cedar 66 (Green dot). All proposed for removal.
