1899 COCHRANE STREET

SAANICH, BC

CONSTRUCTION IMPACT ASSESSMENT

TREE MANAGEMENT PLAN

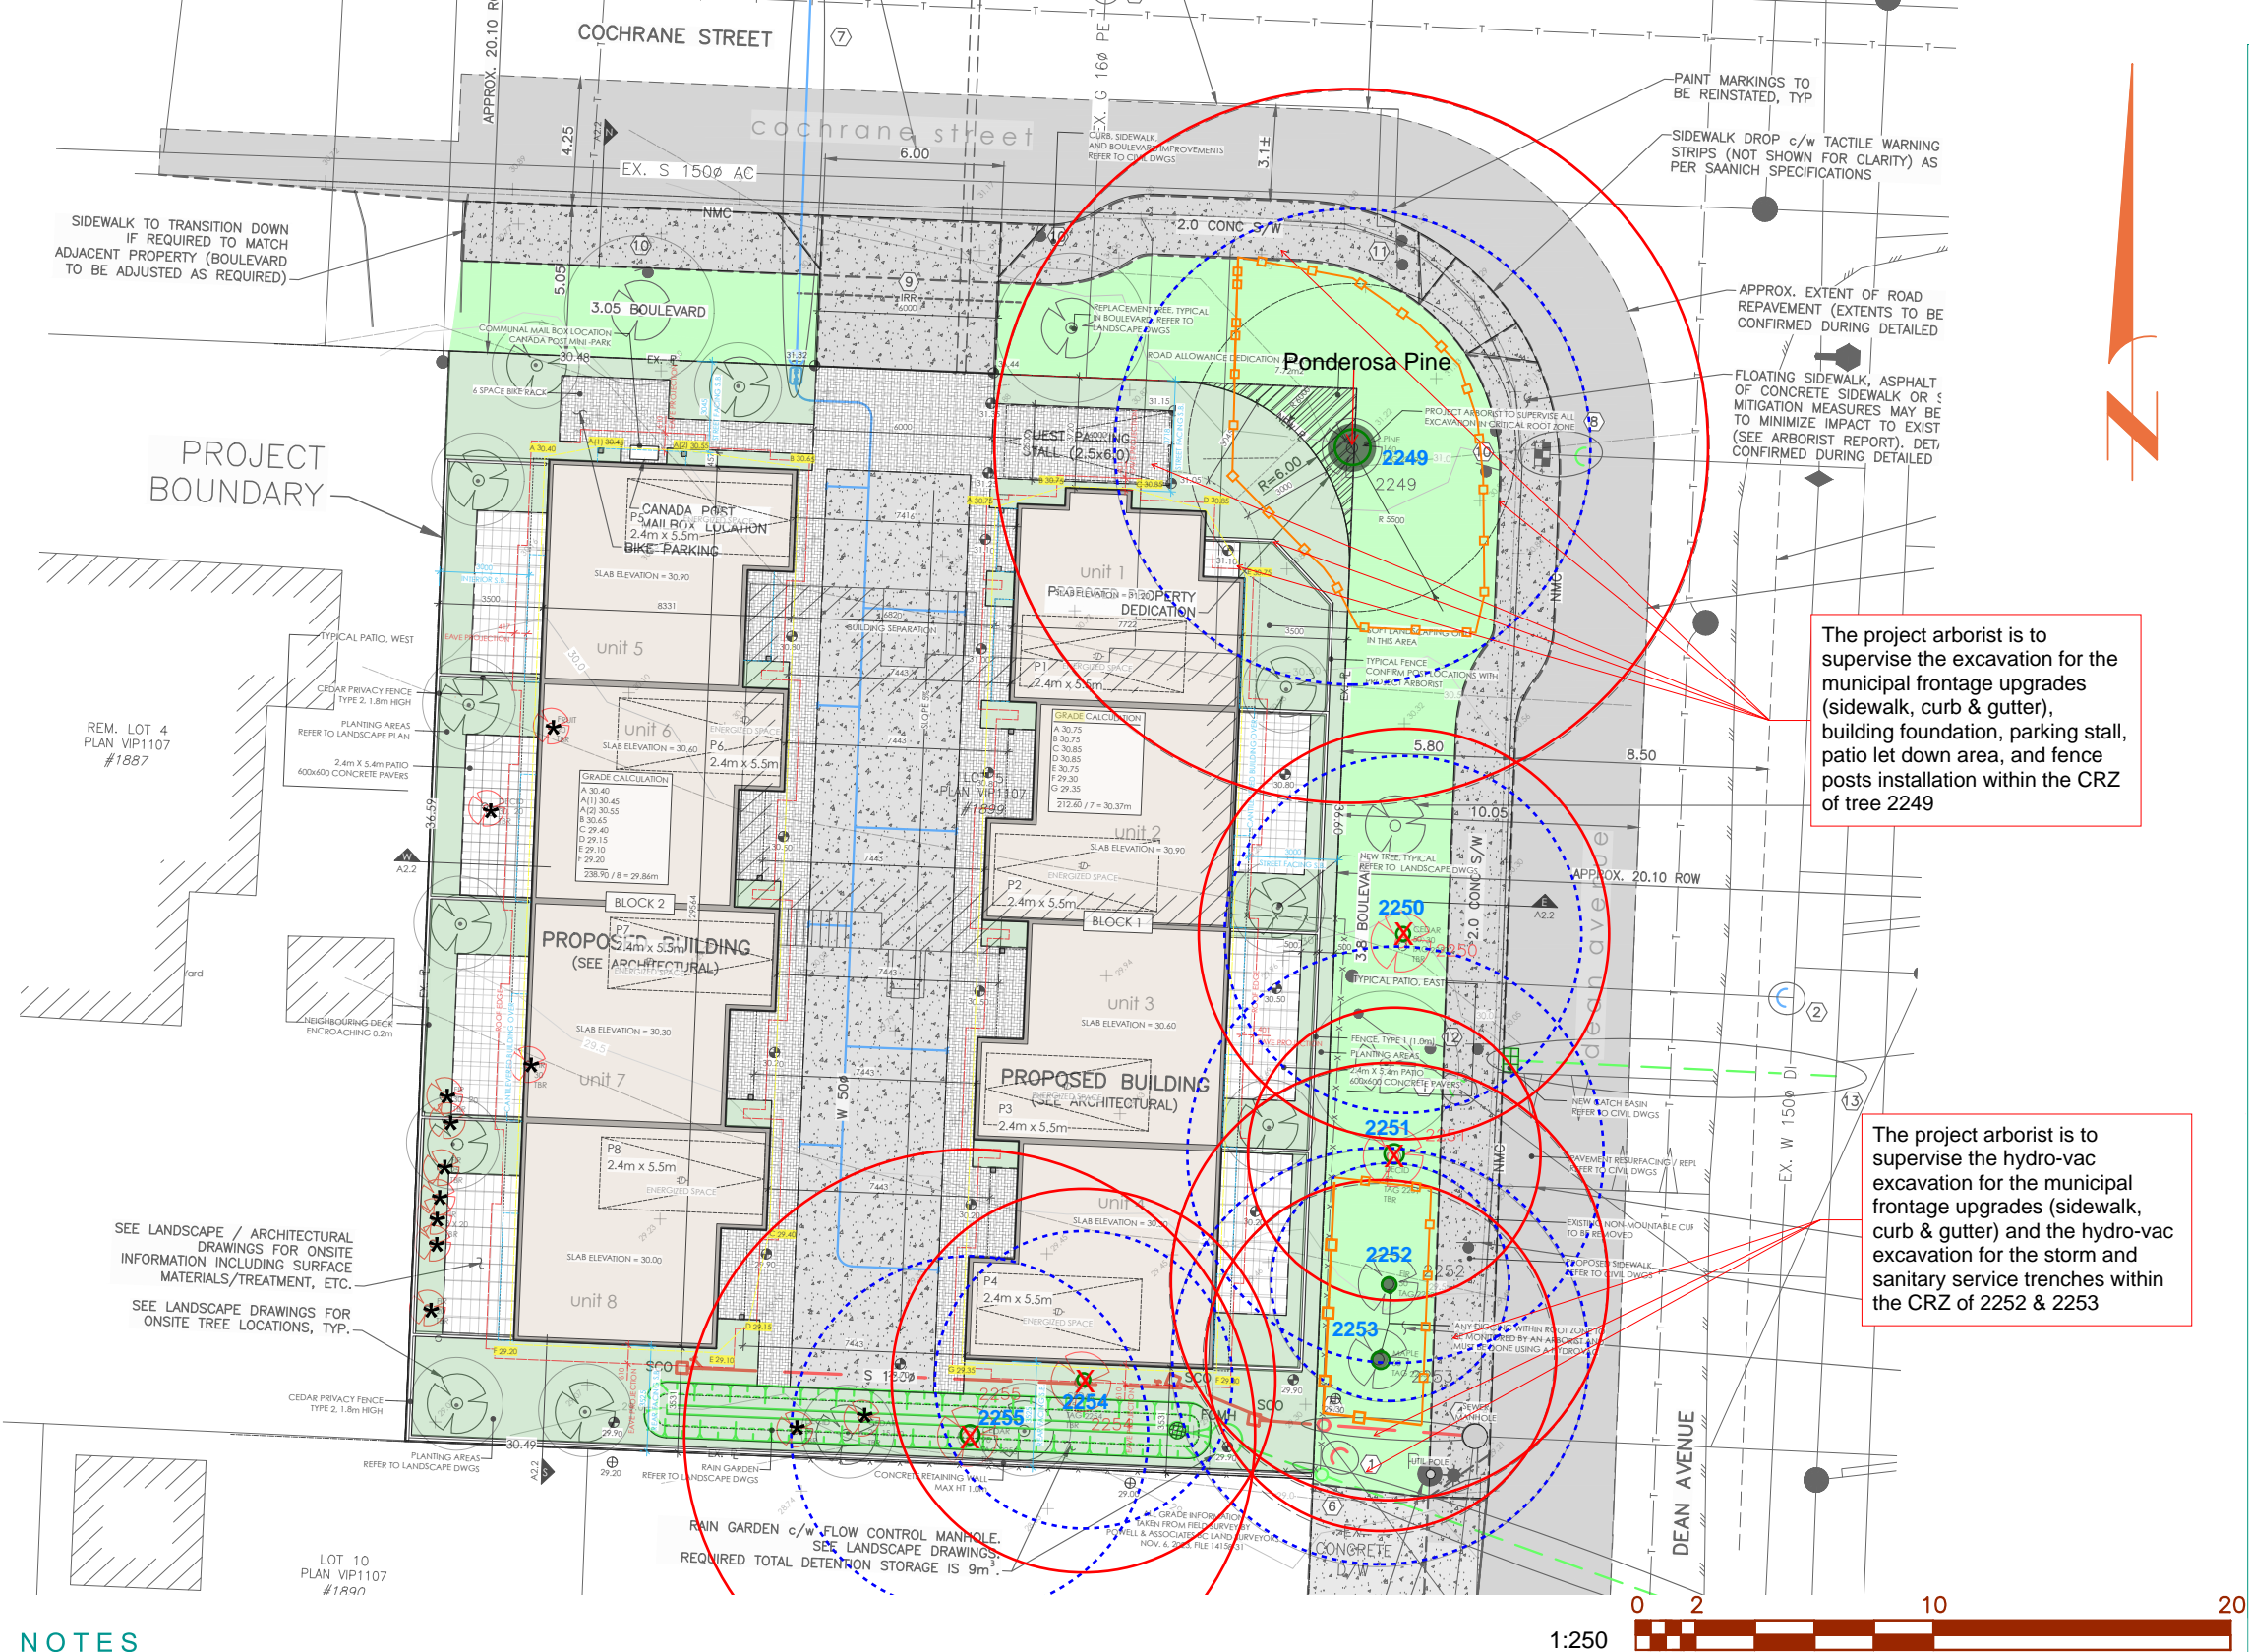
APPENDIX A – TREE MANAGEMENT PLAN (T1)

The following municipal trees (indicated by ID#) are located where they may be possible for retention, however their retention is dictated by the ability to accurately follow the mitigation measures and recommendations outlined in this report. The following trees are listed as Retain* (shown on the tree management plan, [Appendix A, T1](#)):

The proposed sanitary service line is ~2.4m south of tree 2253 with the storm service line being approximately 2m south of the sanitary line. We anticipate roots will be encountered during the excavation required for these service connections. During our on-site review in this area with Saanich's parks department on January 22nd, 2025, it was noted that the existing service lines were ~1-1.5m deep. It is to our understanding that these new services will have to be tied into the existing mains at this depth. Because of this depth required, we believe it may be possible to preserve critical rooting structures if encountered during excavation, as long as they are located above the required depth. These services are to be excavated using a hydro-vac and under arborist supervision. See [Appendix A, T1](#).

Tree ID's: 2250, 2251 – Are located on the municipal boulevard along Dean Avenue. These trees are located where they are likely to be impacted by the proposed construction. These trees are selected for removal based on a combination of impacts and their pre-existing condition.

The following shared bylaw-protected tree (indicated by tag #2249) is located where it may be possible for retention, however its retention is dictated by the ability to accurately follow the mitigation measures and recommendations outlined in this report. The following tree is listed as Retain* (shown on the tree management plan, **Appendix A, T1**):

Tree ID: 2249 – Is a large Ponderosa pine tree located at the corner of the Cochrane Street and Dean Avenue. This tree is likely to be impacted by the building foundation, parking stall, fence and building clearance required for unit 1, along with the municipal frontage upgrades (sidewalk, curb and gutter) at the corner of Cochrane Street and Dean Avenue.

The project arborist is to supervise the excavation for the proposed building foundation of unit 1 within the CRZ of this tree, over excavation may have to be limited to .5m.
